# UFP SITE BUILT

## MUNGO HOMES OF NC

TRUSS:	A4T
JOB ID:	72502041
DELIVERY DATE:	4/10/2025
REQUESTED BY:	Crawford, Marty
EMAIL:	mcrawford@mungo.com
REQUESTED ON:	5/7/2025
SUBDIVISION/MODEL:	CAMBRIDGE RESERVE
LOT #:	52
DELIVERY ADDRESS:	91 BUNKER HILL PLACE ANGIER, NC 27501
REPAIR ID:	MII-REP01A1 (ATTACHED)

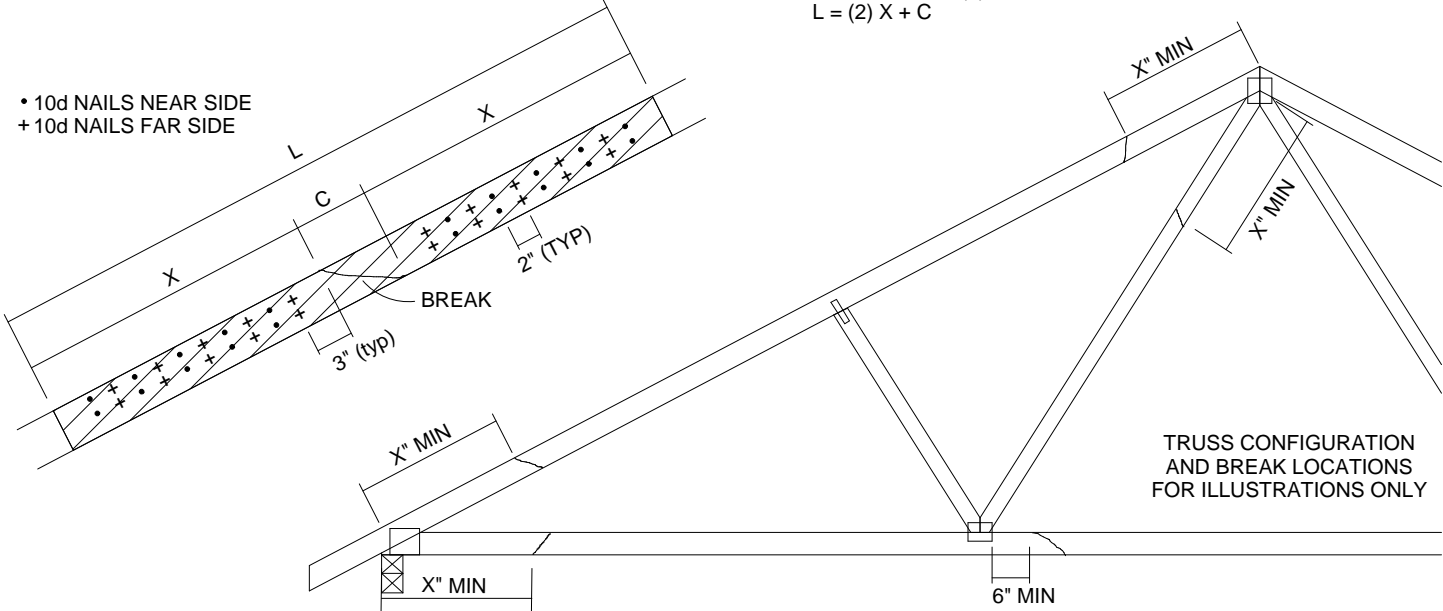
ATTACH 2x SCAB OF THE SAME SIZE AND GRADE AS THE BROKEN MEMBER TO EACH FACE OF THE TRUSS (CENTER ON BREAK OR SPLICE) WITH 10d (0.131" X 3") NAILS (TWO ROWS FOR 2x4, THREE ROWS FOR 2x6) SPACED 4" O.C. AS SHOWN. STAGGER NAIL SPACING FROM FRONT FACE AND BACK FACE FOR A NET 0-2-0 O.C. SPACING IN THE MAIN MEMBER. USE A MIN. 0-3-0 MEMBER END DISTANCE.

THE LENGTH OF THE BREAK (C) SHALL NOT EXCEED 12". (C=PLATE LENGTH FOR SPLICE REPAIRS)

THE MINIMUM OVERALL SCAB LENGTH REQUIRED (L) IS CALCULATED AS FOLLOWS:

$L = (2) \times X + C$

THE LOCATION OF THE BREAK MUST BE GREATER THAN OR EQUAL TO THE REQUIRED X DIMENSION FROM ANY PERIMETER BREAK OR HEEL JOINT AND A MINIMUM OF 6" FROM ANY INTERIOR JOINT (SEE SKETCH ABOVE)

TOTAL NUMBER OF NAILS EACH SIDE OF BREAK *		X INCHES	MAXIMUM FORCE (lbs) 15% LOAD DURATION							
			SP		DF		SPF		HF	
2x4	2x6		2x4	2x6	2x4	2x6	2x4	2x6	2x4	2x6
20	30	24"	1706	2559	1561	2342	1320	1980	1352	2028
26	39	30"	2194	3291	2007	3011	1697	2546	1738	2608
32	48	36"	2681	4022	2454	3681	2074	3111	2125	3187
38	57	42"	3169	4754	2900	4350	2451	3677	2511	3767
44	66	48"	3657	5485	3346	5019	2829	4243	2898	4347

\* DIVIDE EQUALLY FRONT AND BACK

DO NOT USE REPAIR FOR JOINT SPLICES
