RE: Daily Field Report for 07/21/2025
Lot 48 Magnolia Ridge (CMT) Lillington, NC
Building & Earth Project No : RD250703

Field Observations Report

1 : Foundation Inspection Passed

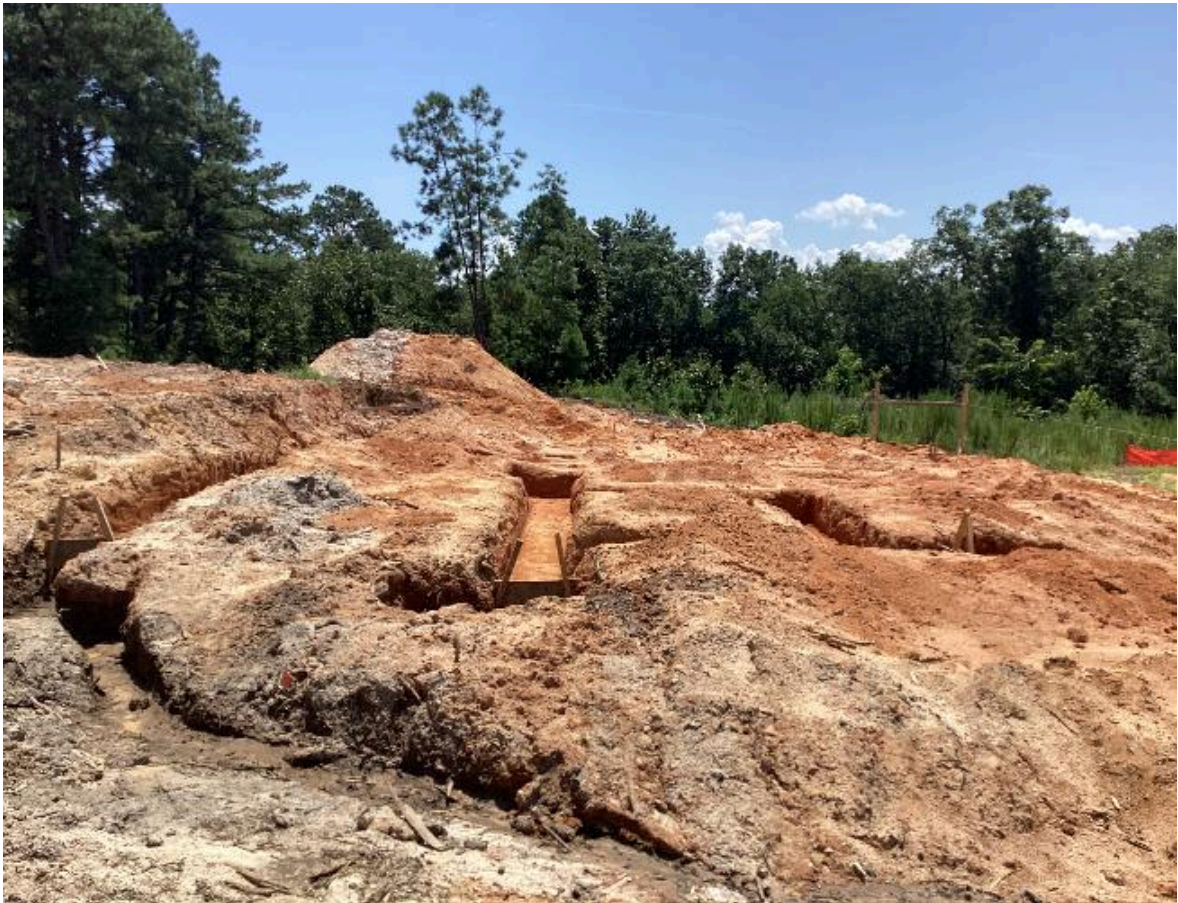
Picture ID	Front
111288

We arrived onsite to evaluate the building pad area for this residential lot. We understand the residence has been designed to be supported on a crawl space foundation. Our evaluation as documented in this report includes:

The site slopes downward from left to right. Building locations are referenced from the street looking at the front of the residence. Maximum relief across the lot is approximately 12 feet. Surface water runoff appears to drain to the right.

The site has been stripped of surface cover and topsoil. It appears that 12 inches of topsoil has been removed from the building pad area.

Structural fill has been placed at the site to level the building pad. Based on our observations, we understand the pad has been filled according to the following:

Based on our observations and test results, the newly placed fill/existing soils appear to be suitable to provide support for the floor slab and footings, provided the floor slab has a loading of less than 150 pounds per square foot, and the footings have a design bearing capacity of 2,000, or less.

To minimize the potential for future softening of the bearing materials due to water infiltration, the surface soils should be protected from construction traffic and inclement weather. The construction of the footings and structure should commence without delay. In the event that the subgrade soils become wet, or otherwise compromised from their current condition, should be observed and retested as necessary by Building and Earth Sciences.
