SK-1 of 1

Caruso Homes
Statesville
Magnolia Acres Lot 18
Great Room Window Framing Detail
Raleigh, North Carolina

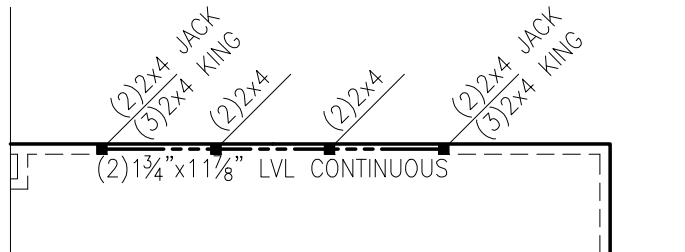
GREAT ROOM WINDOW DETAIL

PROBLEM:

GREAT ROOM WINDOW FRAMING DOES NOT MATCH PERMITTED FRAMING PLANS. JACK STUDS WERE PROVIDED IN THE FIELD, NOT SHOWN ON PLANS.

REPAIR:

PROVIDE FRAMING PER DETAIL SHOWN.
