RE: Daily Field Report for 05/10/2025
Lot 529 Creekside Oaks North (CMT) Lillington, NC
Building & Earth Project No : RD250418

Field Observations Report

Project Name:	Lot 529 Creekside Oaks North (CMT) Lillington, NC	Project Number:	RD250418
Client Name:	Dream Finders Homes-Carolinas	Placement#:	FO-1
Contractor:	Dream Finders Homes-Carolinas	Technician:	Richard Stanek
Monitoring:	DCP

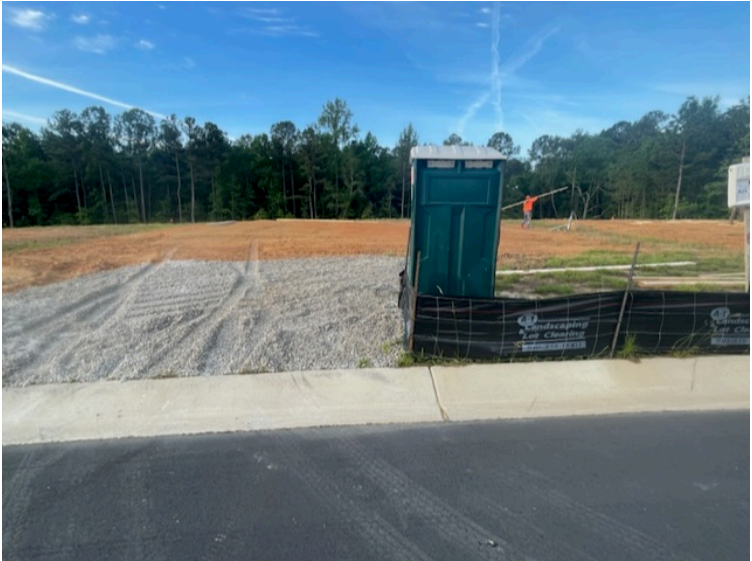
Picture ID	Site
106595

The lot is relatively flat. Building locations are referenced from the street looking at the front of the residence. Maximum relief across the lot is approximately 1 foot. Surface water runoff appears to drain to the left.

The site has been stripped of surface cover and topsoil. It appears that 4-6 inches of topsoil has been removed from the building pad area.
