ATTACH 2x SCAB OF THE SAME SIZE AND GRADE AS THE BROKEN MEMBER TO EACH FACE OF THE TRUSS (CENTER ON BREAK OR SPLICE) WITH 10d (0.131" X 3") NAILS (TWO ROWS FOR 2x4, THREE ROWS FOR 2x6) SPACED 4" O.C. AS SHOWN. STAGGER NAIL SPACING FROM FRONT FACE AND BACK FACE FOR A NET 0-2-0 O.C. SPACING IN THE MAIN MEMBER. USE A MIN. 0-3-0 MEMBER END DISTANCE.

WARNING - Verify design parameters and READ NOTES ON THIS AND INCLUDED MITEK REFERENCE PAGE MII-7473 rev. 1/2/2023 BEFORE USE.

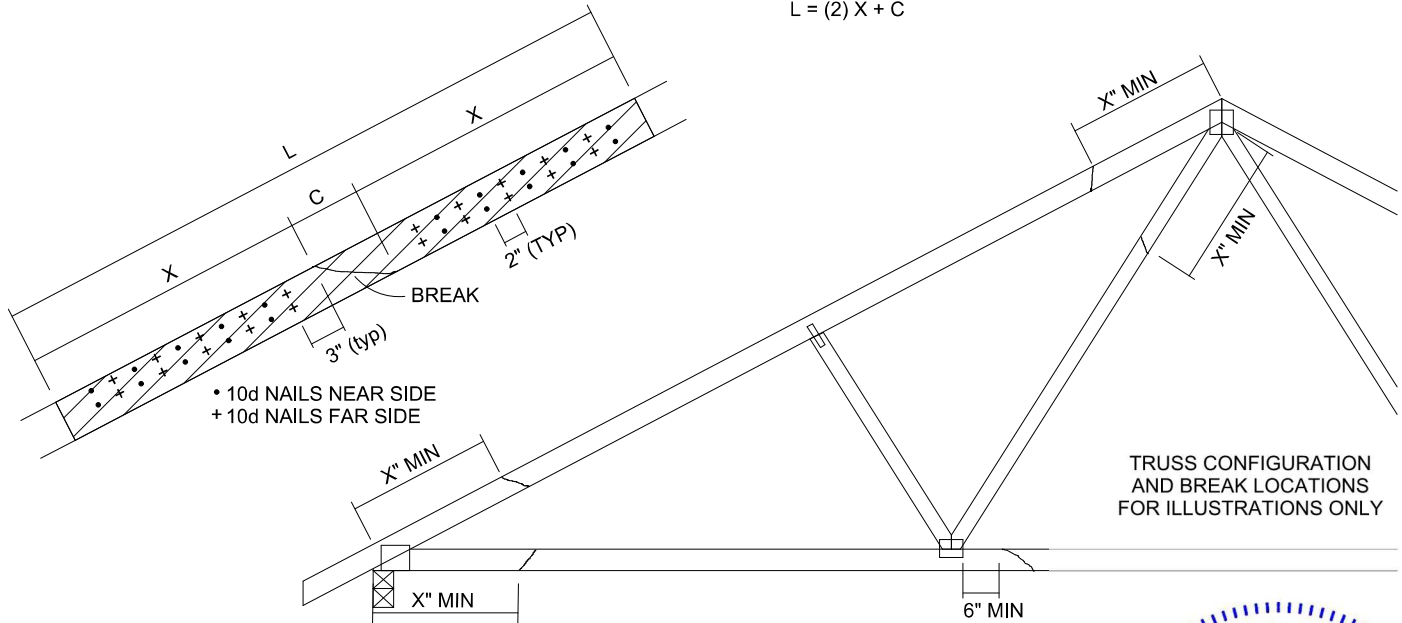
THE LENGTH OF THE BREAK (C) SHALL NOT EXCEED 12". (C=PLATE LENGTH FOR SPLICE REPAIRS)
THE MINIMUM OVERALL SCAB LENGTH REQUIRED (L) IS CALCULATED AS FOLLOWS:
 $L = (2) X + C$

THE LOCATION OF THE BREAK MUST BE GREATER THAN OR EQUAL TO THE REQUIRED X DIMENSION FROM ANY PERIMETER BREAK OR HEEL JOINT AND A MINIMUM OF 6" FROM ANY INTERIOR JOINT (SEE SKETCH ABOVE)

TOTAL NUMBER OF NAILS EACH SIDE OF BREAK *		X INCHES	MAXIMUM FORCE (lbs) 15% LOAD DURATION							
			SP		DF		SPF		HF	
2x4	2x6		2x4	2x6	2x4	2x6	2x4	2x6	2x4	2x6
20	30	24"	1706	2559	1561	2342	1320	1980	1352	2028
26	39	30"	2194	3291	2007	3011	1697	2546	1738	2608
32	48	36"	2681	4022	2454	3681	2074	3111	2125	3187
38	57	42"	3169	4754	2900	4350	2451	3677	2511	3767
44	66	48"	3657	5485	3346	5019	2829	4243	2898	4347

* DIVIDE EQUALLY FRONT AND BACK
