RE: Daily Field Report for 06/20/2025
Lot 541 Creekside Oaks North (CMT) Lillington, NC
Building & Earth Project No : RD250609

Field Observations Report

1 : Foundation Inspection

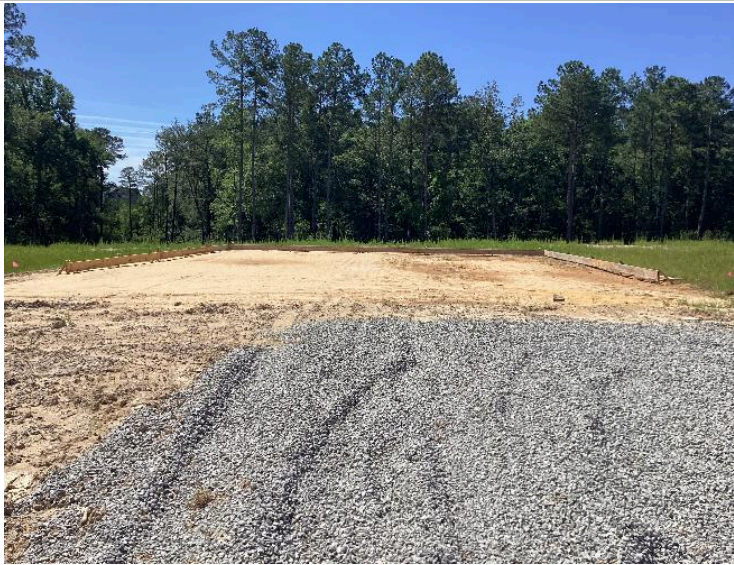
Picture ID	Front
109398

The lot slopes from left to right. Building locations are referenced from the street looking at the front of the residence. Maximum relief across the lot is approximately 5 feet. Surface water runoff appears to drain to the right.

The site has been stripped of surface cover and topsoil. It appears that 6 inches of topsoil has been removed from the building pad area.

Hand Rod Probing: Our representative performed hand rod probing of the surface of the building pad. Hand rod probing of the bearing material generally showed an average penetration of approximately 1 inches. Areas of soft material were noted on the central right half of the lot with the hand rod probing to a depth of about 5 inches.
