RE: 356 Hookbill Lane - Lot 107

Project 356 Hookbill Lane - Lot 107

FIELD REPORT

Report of Foundation Observations

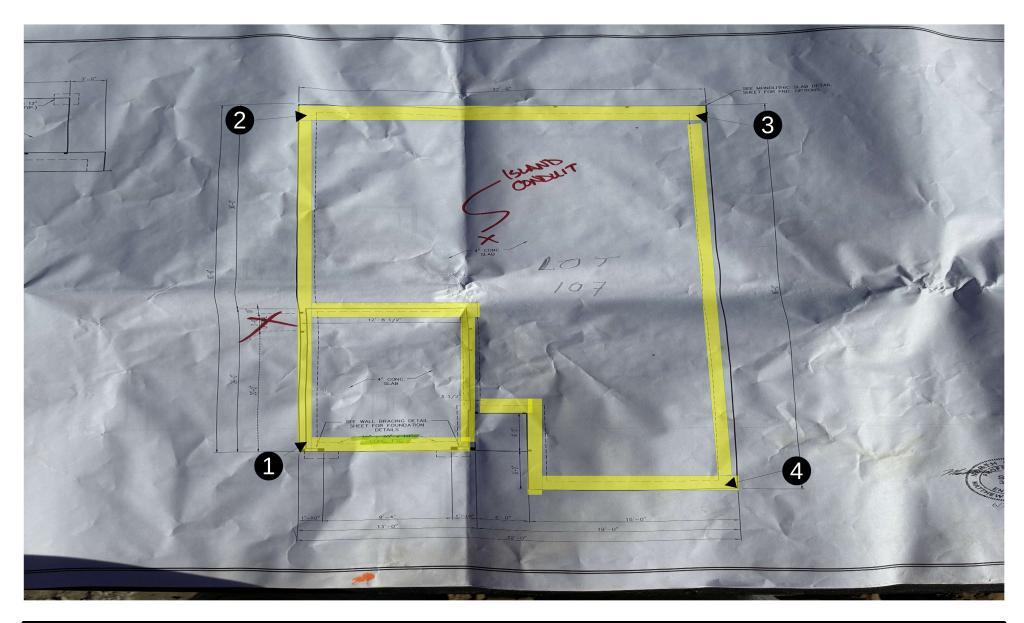
ECS arrived on site, as requested, to check the bearing capacity of soils via hand auger/DCP method (ASTM STP-399) for the monolithic slab foundation footings. Please see the attached sketch and data sheet for details.

A total of 4 hand auger/DCP evaluations were performed to a depth of approximately 3 feet below the current footing sub grade elevation. The test results indicated that the materials in place (at the locations and elevations tested) did appear to be suitable to support the design bearing capacity of 2000 psf.

Trent Garver 09/02/2025 Hookbill Ln Lot 107

Key (NTS)
Footing Locations:

DCP Test Locations:

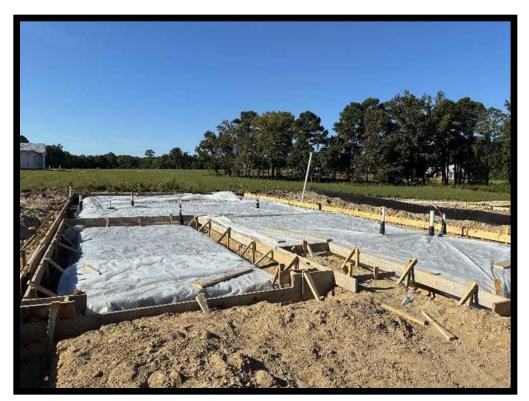
Figure 1

Lot 107
