RE: Daily Field Report for 06/17/2025 Lot 6 Lla's Way (CMT) Dunn, NC

Building & Earth Project No: RD250588

FO-1: Field Observations made on this date.

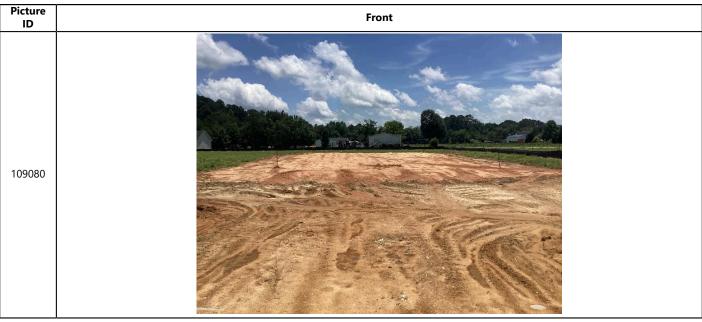
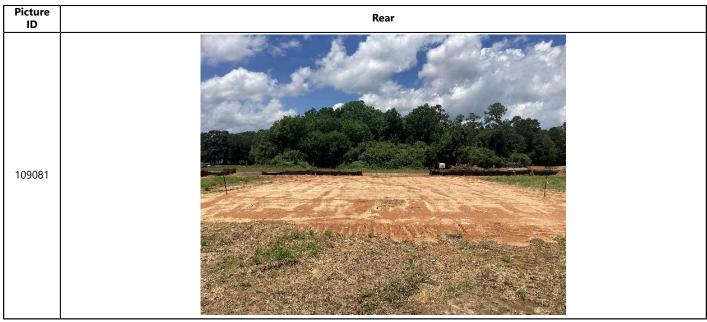
Photographs

The lot slopes from back to front. Building locations are referenced from the street looking at the front of the residence. Maximum relief across the lot is approximately 2 feet. Surface water runoff appears to drain to the front right.

The site has been stripped. It appears that 6 inches of topsoil has been removed from the building pad area.

Hand Rod Probing: Our representative performed hand rod probing of the surface of the building pad. Hand rod probing of the bearing material generally showed an average penetration of approximately 4 inches.

To minimize the potential for future softening of the bearing materials due to water infiltration, the surface soils should be protected from construction traffic and inclement weather. The construction of the footings and structure should commence without delay. In the event that the subgrade soils become wet, or otherwise compromised from their current condition, should be observed and retested as necessary by Building and Earth Sciences.
