**RE:** Daily Field Report for 06/10/2025  
Lot 459 Colony at Lexington (CMT) Cameron, NC  
Building & Earth Project No : RD250534

## Field Observations Report

### 1 : Foundation Inspection

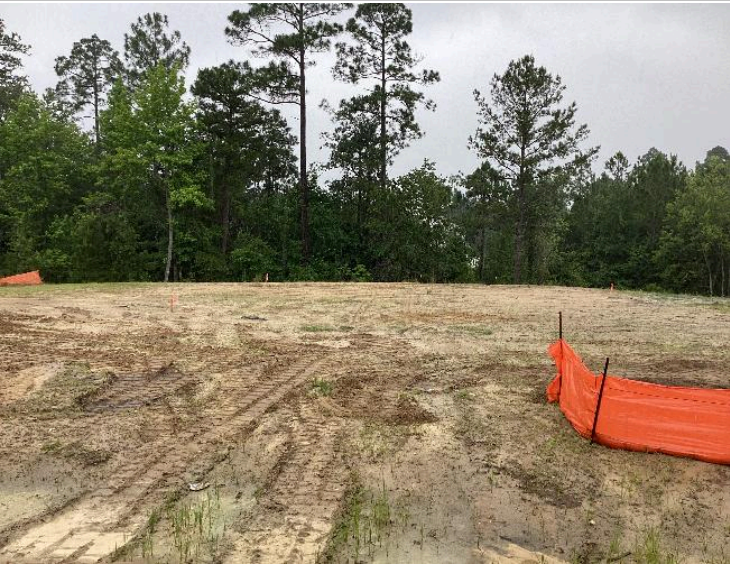
Picture ID	Front
108110

The lot is sloped front to back. Building locations are referenced from the street looking at the front of the residence. Maximum relief across the lot is approximately 2 feet. Surface water runoff appears to drain to rear of lot.

The site has been stripped of surface cover and topsoil. It appears that 8 inches of topsoil has been removed from the building pad area.

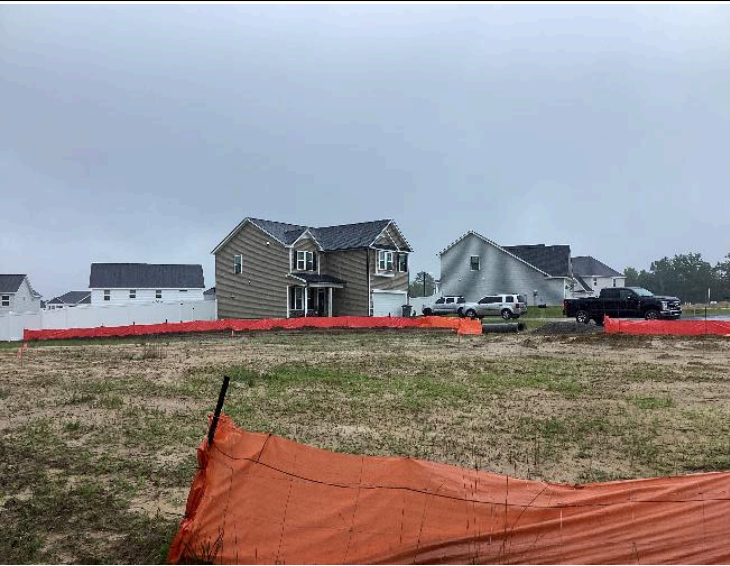
Picture ID	Left Rear
108112

Structural fill has been placed at the site to level the building pad. Based on our observations, we understand the pad has been filled according to the following:

Section-----	Thickness of Fill
Left Front-----	24 inches of fill
Left Rear-----	30 inches of fill
Center-----	28 inches of fill
Right Front-----	24 inches of fill
Right Rear-----	30 inches of fill
