RE: Daily Field Report for 06/20/2025
Lot 480 Colony at Lexington (CMT) Cameron, NC
Building & Earth Project No : RD250607

Field Observations Report

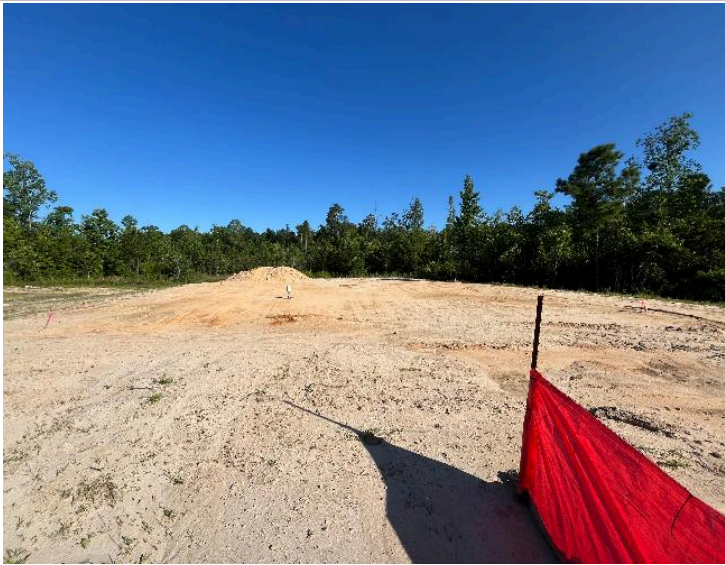
Picture ID	Front
109300

The lot sloped downward from front to back. Building locations are referenced from the street looking at the front of the residence. Maximum relief across the lot is approximately 2 feet. Surface water runoff appears to drain to the rear.

The site has been stripped of surface cover and topsoil. It appears that 8 inches of topsoil has been removed from the building pad area.

Test 1: [Front Center]

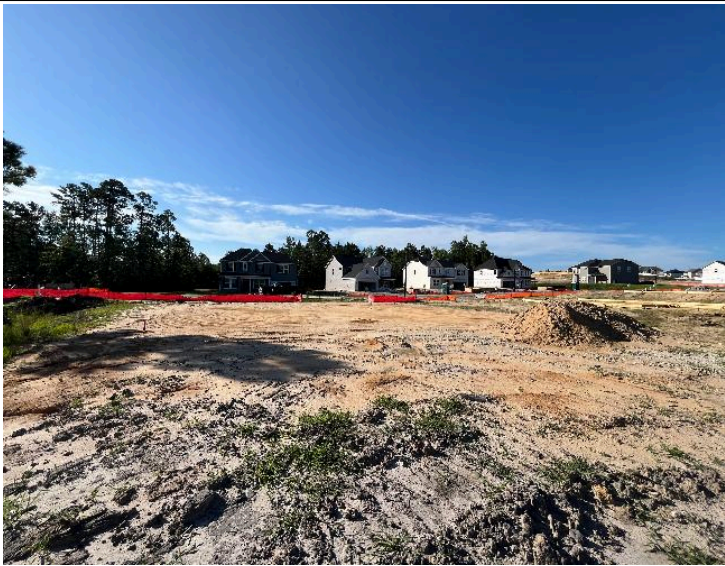
Picture ID	Rear
109302

Test 2: [Rear Center]
