UFP SITE BUILT
A UFP INDUSTRIES COMPANY

TRUSS: A2
JOB ID: 72513620
DELIVERY DATE: 9/8/2025

SUBDIVISION/MODEL: LEANDER LEE PRESERVE
LOT #: 65

REPAIR ID: MII-REP01A1 (ATTACHED)

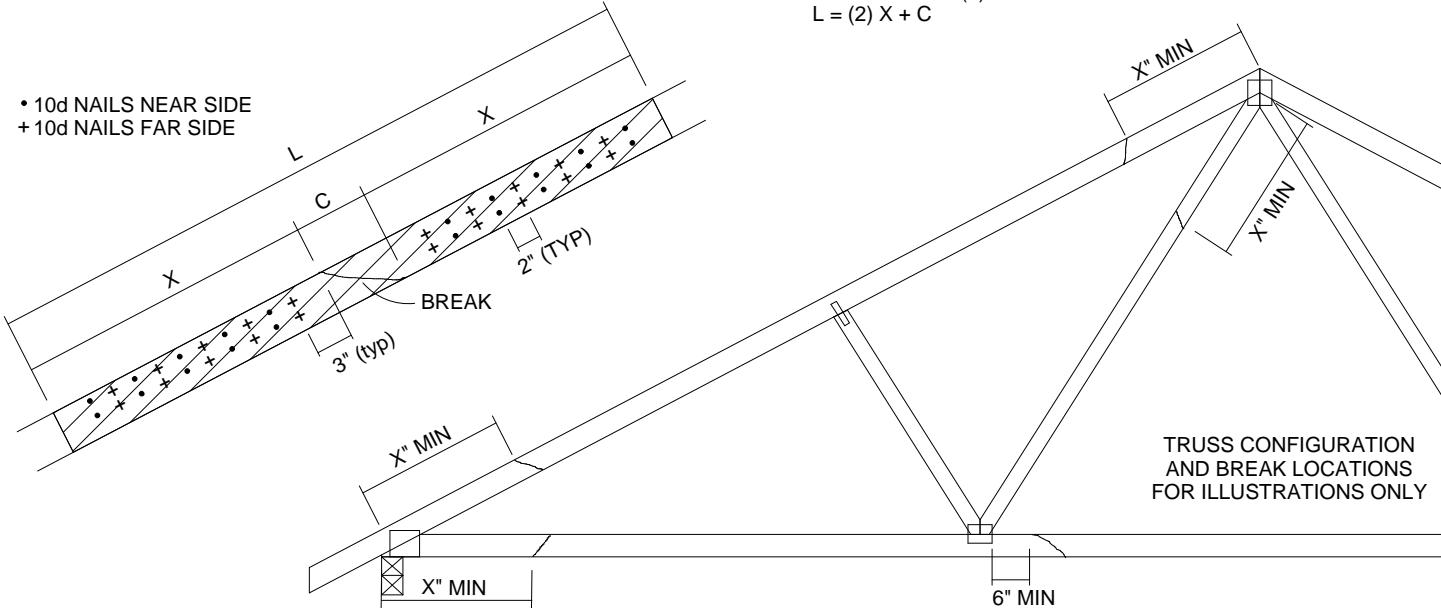
ATTACH 2x_ SCAB OF THE SAME SIZE AND GRADE AS THE BROKEN MEMBER TO EACH FACE OF THE TRUSS (CENTER ON BREAK OR SPLICE) WITH 10d (0.131" X 3") NAILS (TWO ROWS FOR 2x4, THREE ROWS FOR 2x6) SPACED 4" O.C. AS SHOWN.

STAGGER NAIL SPACING FROM FRONT FACE AND BACK FACE FOR A NET 0-2-0 O.C. SPACING IN THE MAIN MEMBER. USE A MIN. 0-3-0 MEMBER END DISTANCE.

THE LENGTH OF THE BREAK (C) SHALL NOT EXCEED 12". (C=PLATE LENGTH FOR SPLICE REPAIRS)
THE MINIMUM OVERALL SCAB LENGTH REQUIRED (L) IS CALCULATED AS FOLLOWS:

$$L = (2) X + C$$

THE LOCATION OF THE BREAK MUST BE GREATER THAN OR EQUAL TO THE REQUIRED X DIMENSION FROM ANY PERIMETER BREAK OR HEEL JOINT AND A MINIMUM OF 6" FROM ANY INTERIOR JOINT (SEE SKETCH ABOVE)

TOTAL NUMBER OF NAILS EACH SIDE OF BREAK *		X INCHES	MAXIMUM FORCE (lbs) 15% LOAD DURATION							
			SP		DF		SPF		HF	
2x4	2x6		2x4	2x6	2x4	2x6	2x4	2x6	2x4	2x6
20	30	24"	1706	2559	1561	2342	1320	1980	1352	2028
26	39	30"	2194	3291	2007	3011	1697	2546	1738	2608
32	48	36"	2681	4022	2454	3681	2074	3111	2125	3187
38	57	42"	3169	4754	2900	4350	2451	3677	2511	3767
44	66	48"	3657	5485	3346	5019	2829	4243	2898	4347

* DIVIDE EQUALLY FRONT AND BACK

DO NOT USE REPAIR FOR JOINT SPLICES
