**RE:** Daily Field Report for 07/25/2025  
Lot 9 Ducks Landing (CMT) Lillington, NC  
Building & Earth Project No : RD250693

## Field Observations Report

### 1 : Foundation Inspection

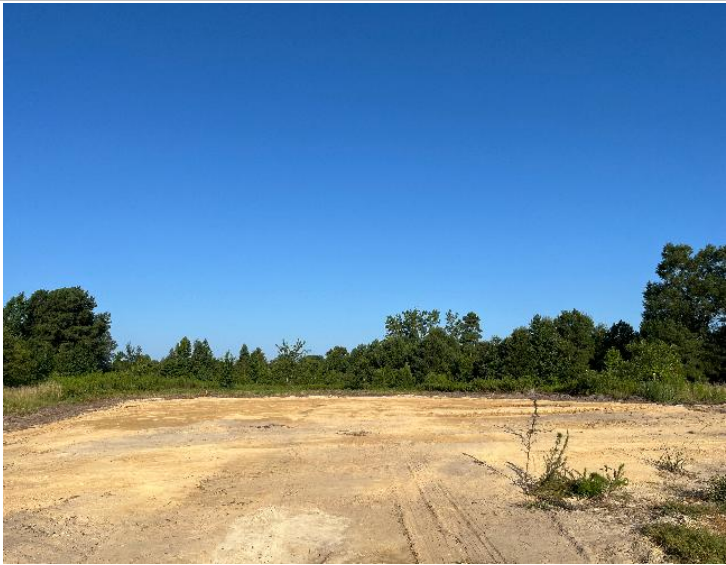
| Picture ID | Front |
|---|---|
| 111553 | |

The lot is sloped. The site slopes downward from back to front. Building locations are referenced from the street looking at the front of the residence. Surface water runoff appears to drain to a drainage ditch system at the front of the lot.

| Picture ID | Front |
