**RE:** Daily Field Report for 07/25/2025  
Lot 85 Ducks Landing (CMT) Lillington, NC  
Building & Earth Project No : RD250618

## Field Observations Report

### 1 : Foundation Inspection Passed

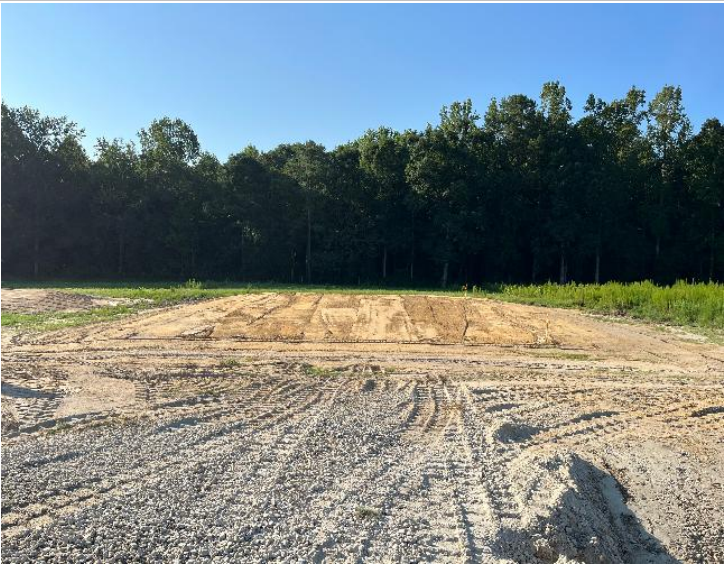
| Picture ID | Front |

The lot is sloped. The site slopes downward from front to back. Building locations are referenced from the street looking at the front of the residence. Surface water runoff appears to drain to a drainage ditch system at the front of the lot.

The site has been stripped of surface cover and topsoil.

Structural fill has been placed at the site to level the building pad. Based on our observations, we understand the pad has been filled according to the following:
