**RE:** Daily Field Report for 07/03/2025  
Lot 100 Ducks Landing (CMT) Lillington, NC  
Building & Earth Project No : RD250623

## Field Observations Report

### 1 : Foundation Inspection

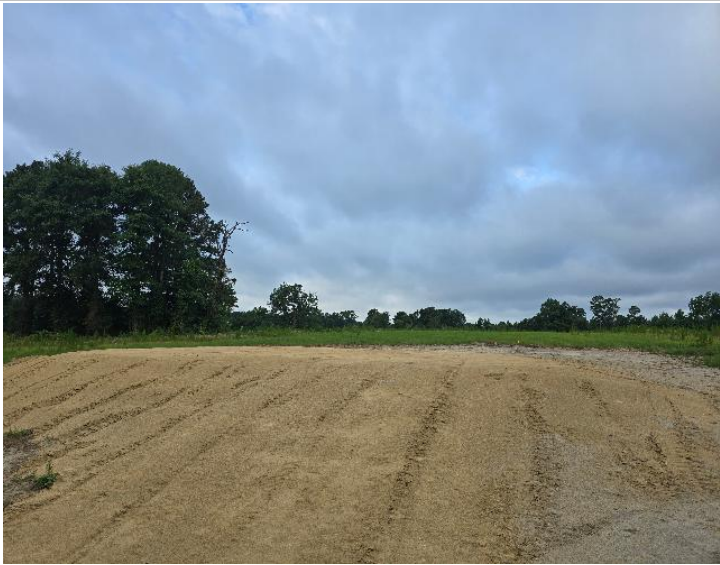
| Picture ID | Front Right of Lot 100 |
|---|---|
| 110285 | |

| Picture ID | Front Right of Lot 100 |

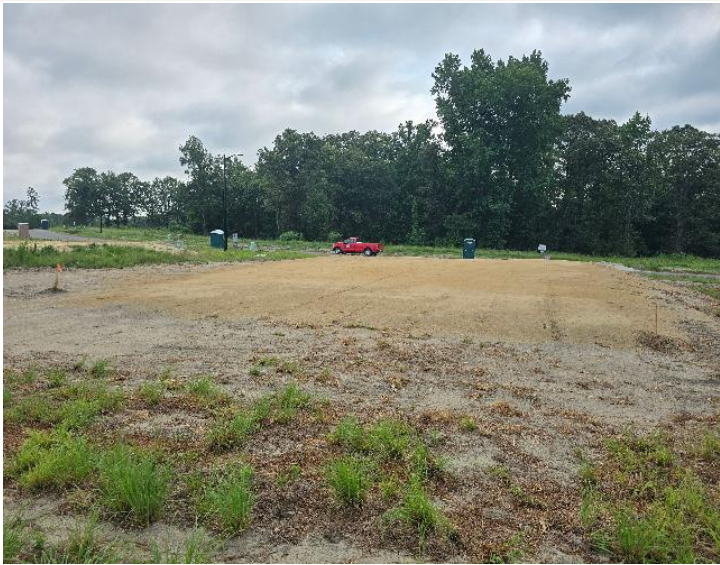
| Picture ID | Front Right of Lot 100 |
|---|---|
| 110286 | |

| Picture ID | Front Right of Lot 100 |
|---|---|
| Picture ID | Rear Left of Lot 100 |
