**RE:** Daily Field Report for 07/02/2025  
Lot 94 Ducks Landing (CMT) Lillington, NC  
Building & Earth Project No : RD250619

## Field Observations Report

### 1 : Foundation Inspection

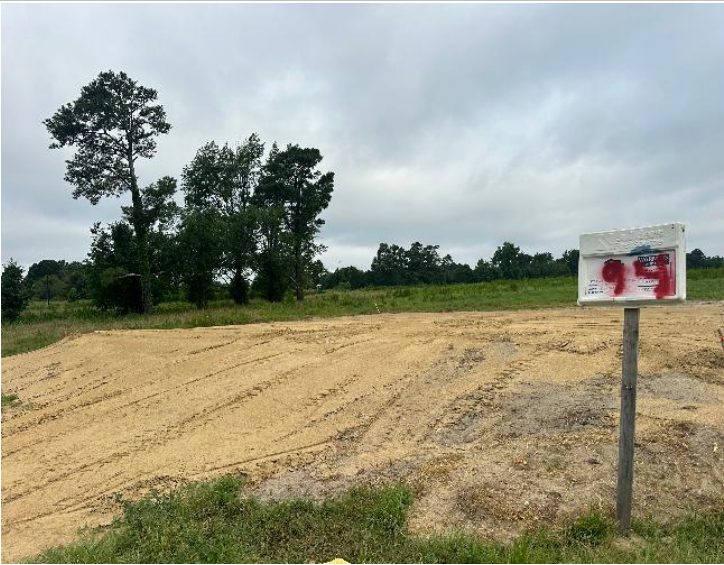
| Picture ID | Front |
|---|---|
| 110242 | |

The lot sloped slightly front to back. Building locations are referenced from the street looking at the front of the residence. Maximum relief across the lot is approximately 3 feet. Surface water runoff appears to drain towards the front.

| Picture ID | Front |
