**RE:** Daily Field Report for 09/04/2025  
Lot 579 Creekside Oaks North (CMT) Lillington, NC  
Building & Earth Project No : RD250808

## Field Observations Report

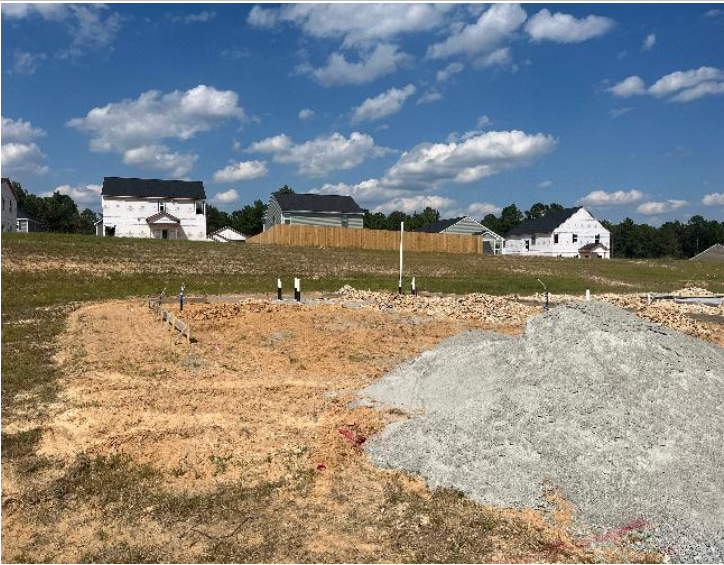
| Picture ID | Front |
|---|---|
| 113804 | |

The lot slopes downward from back to front. Building locations are referenced from the street looking at the front of the residence. Maximum relief across the lot is approximately 1 foot. Surface water runoff appears to drain to the front.

The site has been stripped of surface cover and topsoil. It appears that 6 inches of topsoil has been removed from the building pad area.

| Picture ID | Front |

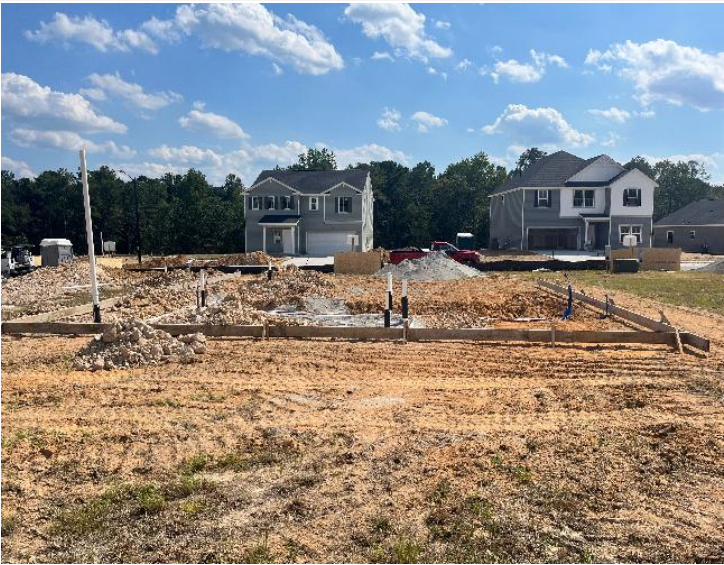
| Picture ID | Front |
|---|---|
| 113805 | |

| Picture ID | Front |
|---|---|
| Picture ID | Rear |
