**RE:** Daily Field Report for 08/27/2025  
Lot 540 Creekside Oaks North (CMT) Lillington, NC  
Building & Earth Project No : RD250802

## Field Observations Report

### 1 : Foundation Inspection

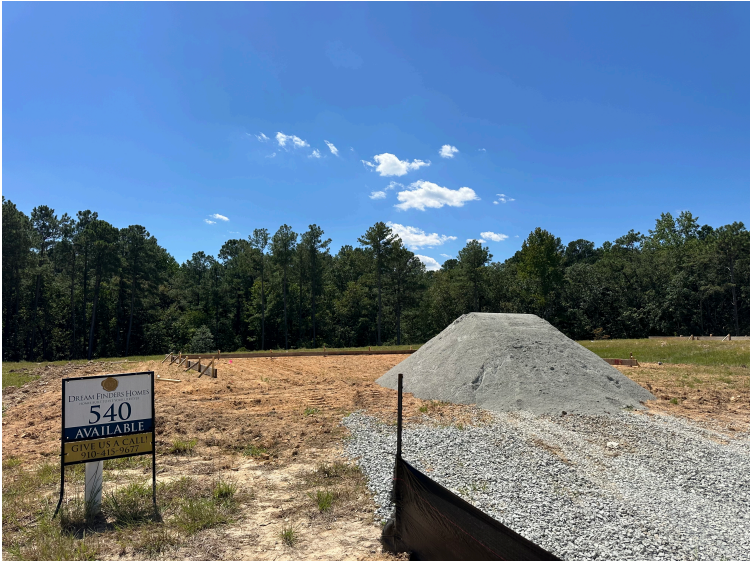
| Picture ID | Front |

The lot slopes right to left. Building locations are referenced from the street looking at the front of the residence. Maximum relief across the lot is approximately 2 feet. Surface water runoff appears to drain towards the left.

The site has been stripped of surface cover and topsoil. It appears that 1 inch of topsoil has been removed from the building pad area.
