STANDARD REPAIR DETAIL FOR BROKEN CHORDS, WEBS
AND DAMAGED OR MISSING CHORD SPLICE PLATES

MII-REP01A1

MiTek USA, Inc. Page 1 of 1

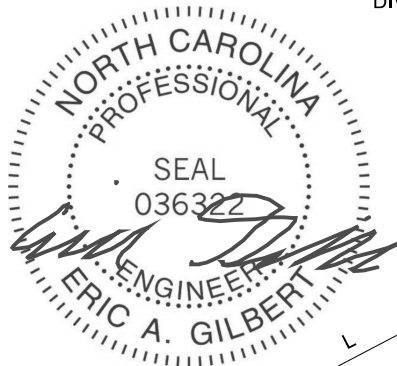
ATTACH 2x SCAB OF THE SAME SIZE AND GRADE AS THE BROKEN MEMBER TO EACH FACE OF THE TRUSS (CENTER ON BREAK OR SPLICE) WITH 10d (0.131" X 3") NAILS (TWO ROWS FOR 2x4, THREE ROWS FOR 2x6) SPACED 4" O.C. AS SHOWN. STAGGER NAIL SPACING FROM FRONT FACE AND BACK FACE FOR A NET 0-2-0 O.C. SPACING IN THE MAIN MEMBER. USE A MIN. 0-3-0 MEMBER END DISTANCE.

THE LENGTH OF THE BREAK (C) SHALL NOT EXCEED 12". (C=PLATE LENGTH FOR SPLICE REPAIRS)
THE MINIMUM OVERALL SCAB LENGTH REQUIRED (L) IS CALCULATED AS FOLLOWS:
 $L = (2) X + C$

TOTAL NUMBER OF NAILS EACH SIDE OF BREAK *		X INCHES	MAXIMUM FORCE (lbs) 15% LOAD DURATION							
			SP		DF		SPF		HF	
2x4	2x6		2x4	2x6	2x4	2x6	2x4	2x6	2x4	2x6
20	30	24"	1706	2559	1561	2342	1320	1980	1352	2028
26	39	30"	2194	3291	2007	3011	1697	2546	1738	2608
32	48	36"	2681	4022	2454	3681	2074	3111	2125	3187
38	57	42"	3169	4754	2900	4350	2451	3677	2511	3767
44	66	48"	3657	5485	3346	5019	2829	4243	2898	4347

* DIVIDE EQUALLY FRONT AND BACK

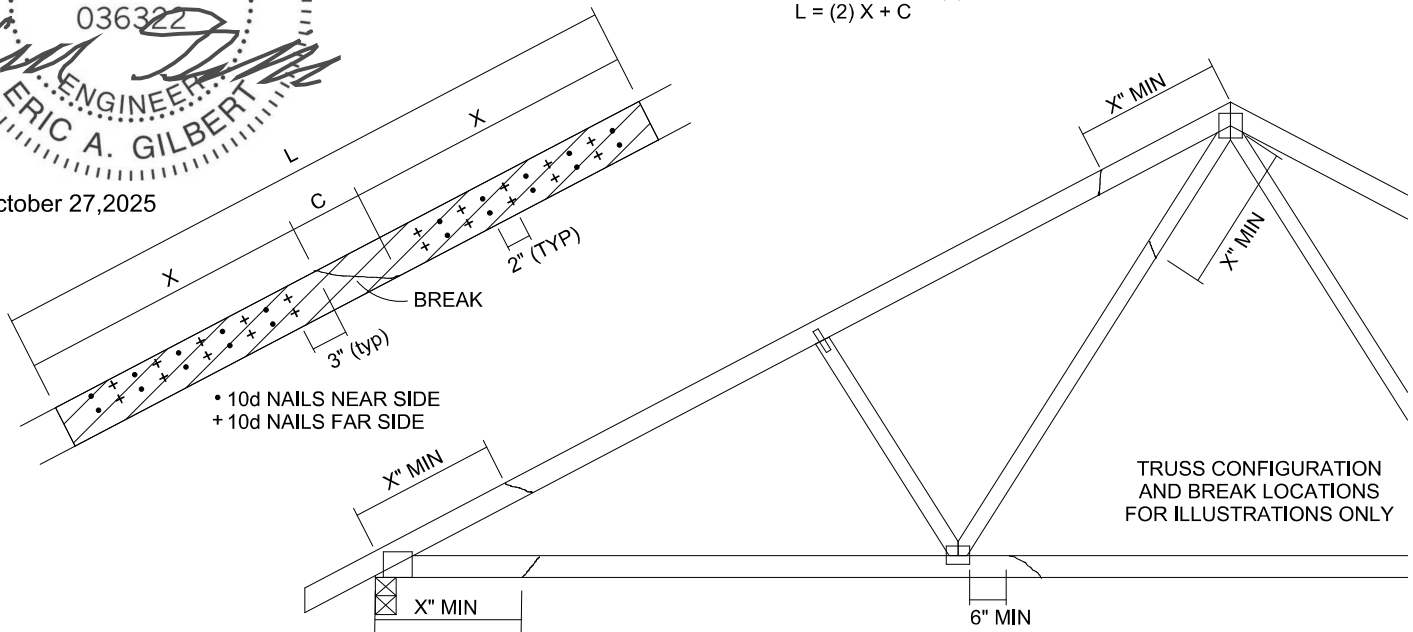
THE LOCATION OF THE BREAK MUST BE GREATER THAN OR EQUAL TO THE REQUIRED X DIMENSION FROM ANY PERIMETER BREAK OR HEEL JOINT AND A MINIMUM OF 6" FROM ANY INTERIOR JOINT (SEE SKETCH ABOVE)

DO NOT USE REPAIR FOR JOINT SPLICES
