Pre-Demolition Asbestos Survey Report

**Erwin Elementary School
301 South 10th Street
Erwin, North Carolina**

October 2, 2019
Terracon Project No. 70197439

Re: Pre-Demolition Asbestos Survey
Erwin Elementary School
301 South 10th Street
Erwin, North Carolina 28339
Terracon Project No.: 70197439

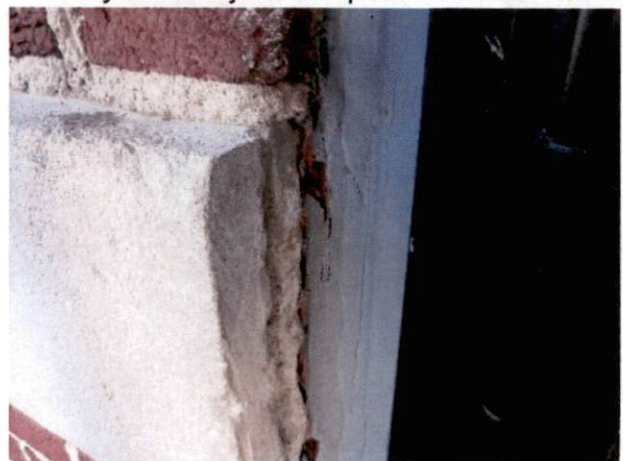
Photo #30 View of HA 26, non-asbestos containing red exterior door caulk.
